Bacteria and Fungi test in air at Lindholmens Sewage treatment plant

Introduction

Test 1

Test 2

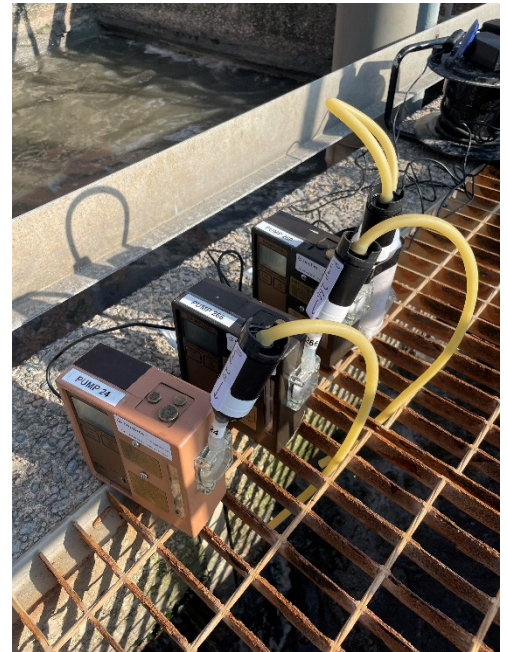
Figure 1: Test 1 at start

Three pumps with detecting filter on the inlet. The pumps were placed beside each other as in picture 1 and air was taken above the sewage stream on the intake to the plant.

Pump capacity was approx. 1,6 L/min.

Sorbonite® fraction: 2-6 mm

Pump 1: inlet air

Pump 2: Reference inlet air

Pump 3: Inlet air with Sorbonite® filter

Sorbonite®: 156 g

90,8 % reduction of bacteria

80,0 % reduction of fungi

Comment: During the first hours the hose to pump 1 came loose. Air was pumped from above the pump instead of from above the water. This result is not used for result.

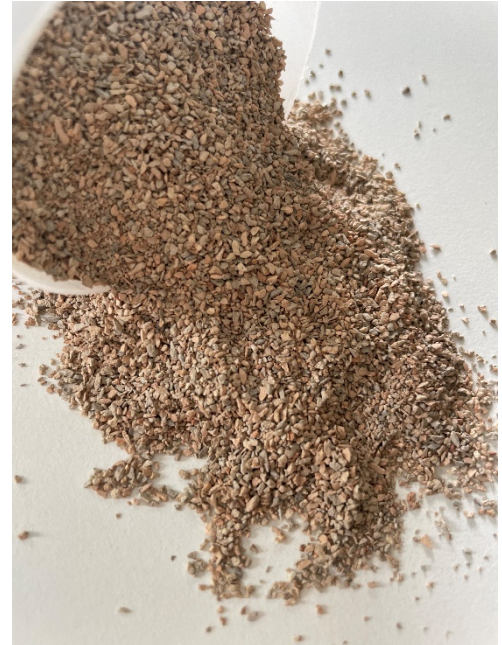
Figure 2: 0,5-1 mm fraction in test 2

Three pumps with detecting filter on the inlet. The pumps were placed beside each other as in picture 1 and air was taken above the sewage stream on the intake to the plant.

Sorbonite® fraction: 0,5-1 mm

Sorbonite®: 139 g

>99 % reduction of bacteria (Average values from pump 1 and 2)

>79,7 % reduction of fungi (Average values from pump 1 and 2)

When using smaller fraction of Sorbonite® the total surface of high pH increases that is more effective to reduce bacteria and fungi. We know by experience that a larger fraction has good odor reduction even if all bacteria is not reduced.
